# **INCIDENT REPORT INCIDENT AT GELDINGAFELL ON THE 7<sup>TH</sup> OF JANUARY MOUNTAINEERS OF ICELAND**

Haukur Herbertsson  
Operations Manager

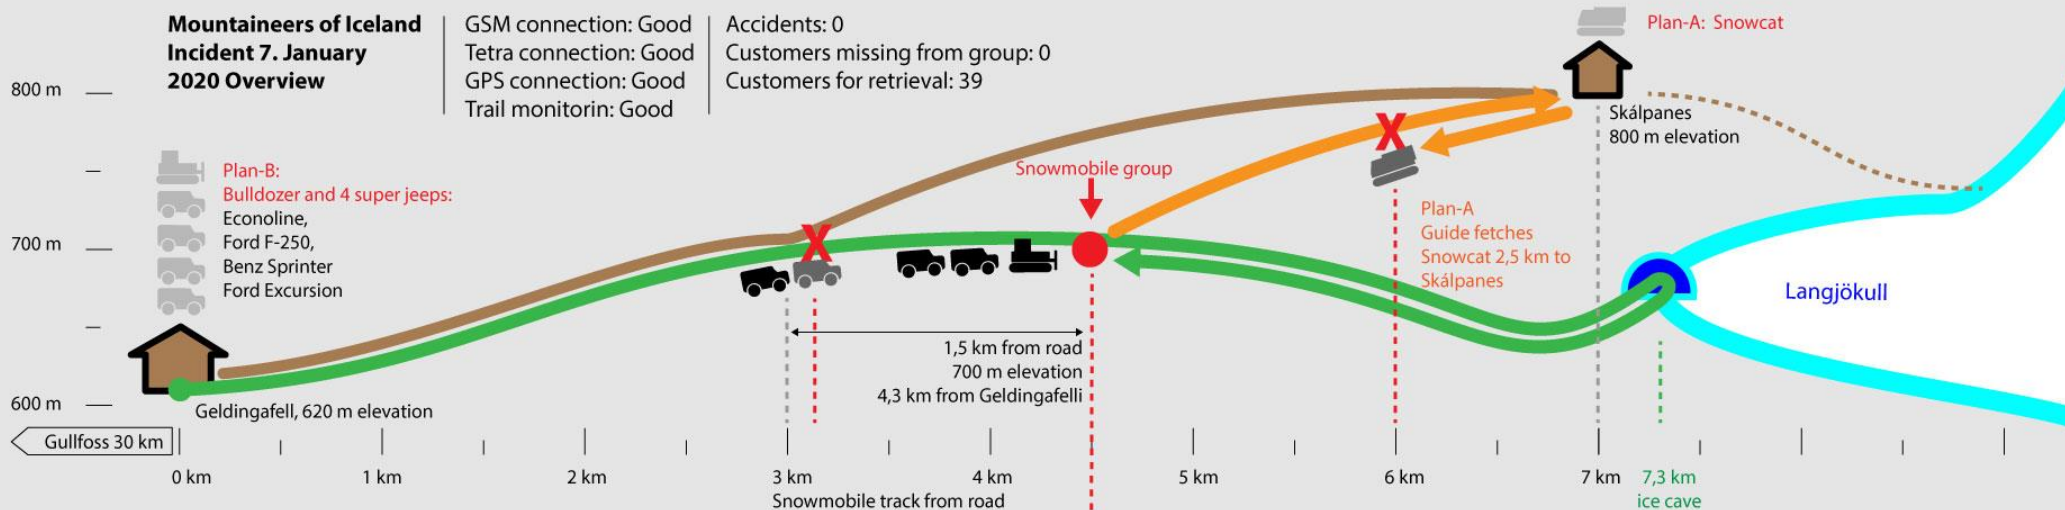
**Mountaineers of Iceland  
Incident 7. January  
2020 Overview**

m/sek	Timi	Event
-1°C	12:50	Snowmobile group departs for trip - 39 customers
-1°C	14:16	Snowmobile group heads back
-3°C	15:20	Back-up plans visited
-4°C	16:15	<b>Plan-A</b> Guide reports troubles due to rough conditions and requests assistance <b>Snowmobile groups is stopped - guides arrange shelter along snowmobiles - 1 guide fetches snowcat</b> <b>Snowcat fails and stops</b>
-5°C	17:30	
-5°C	17:50	<b>Plan-B</b> - Group from Flúðir departs from Geldingafell basecamp with a bulldozer leading the Econoline, Ford F-250, Benz Sprinter and Ford Excursion
-7°C	19:30	19:30 Super jeep nr.3 suffers from malfunctioning
-7°C	19:32	<b>Plan-C</b> - 112 emergency service are called to inform of pending situation
-8°C	19:40	Super jepp nr. 3 stops and cannot continue, it blocks super jeep nr. 4
-8°C	19:59	112 emergency services are called, asking for assistance due to the malfunction of super jeep
-8°C	20:28	Super jeeps nr. 1 og 2 arrive to the group - customers seek shelter in vehicles

-8°C	00:15	Super jepp nr. 4 arrives - Guides start preparing departure by super jeep to Geldingafell basecamp
-8°C	00:30	First responders arrive (á vélsleðum) and assume control. Transport is paused
-8°C	01:00	Ice-SAR resume transport of customers by belted vehicles
-8°C	01:45	First group of 13 customers arrive to Geldingafell with help of Ice-SAR (by belted vehicles)
-8°C	03:31	Last 2 customers arrive at Geldingafell

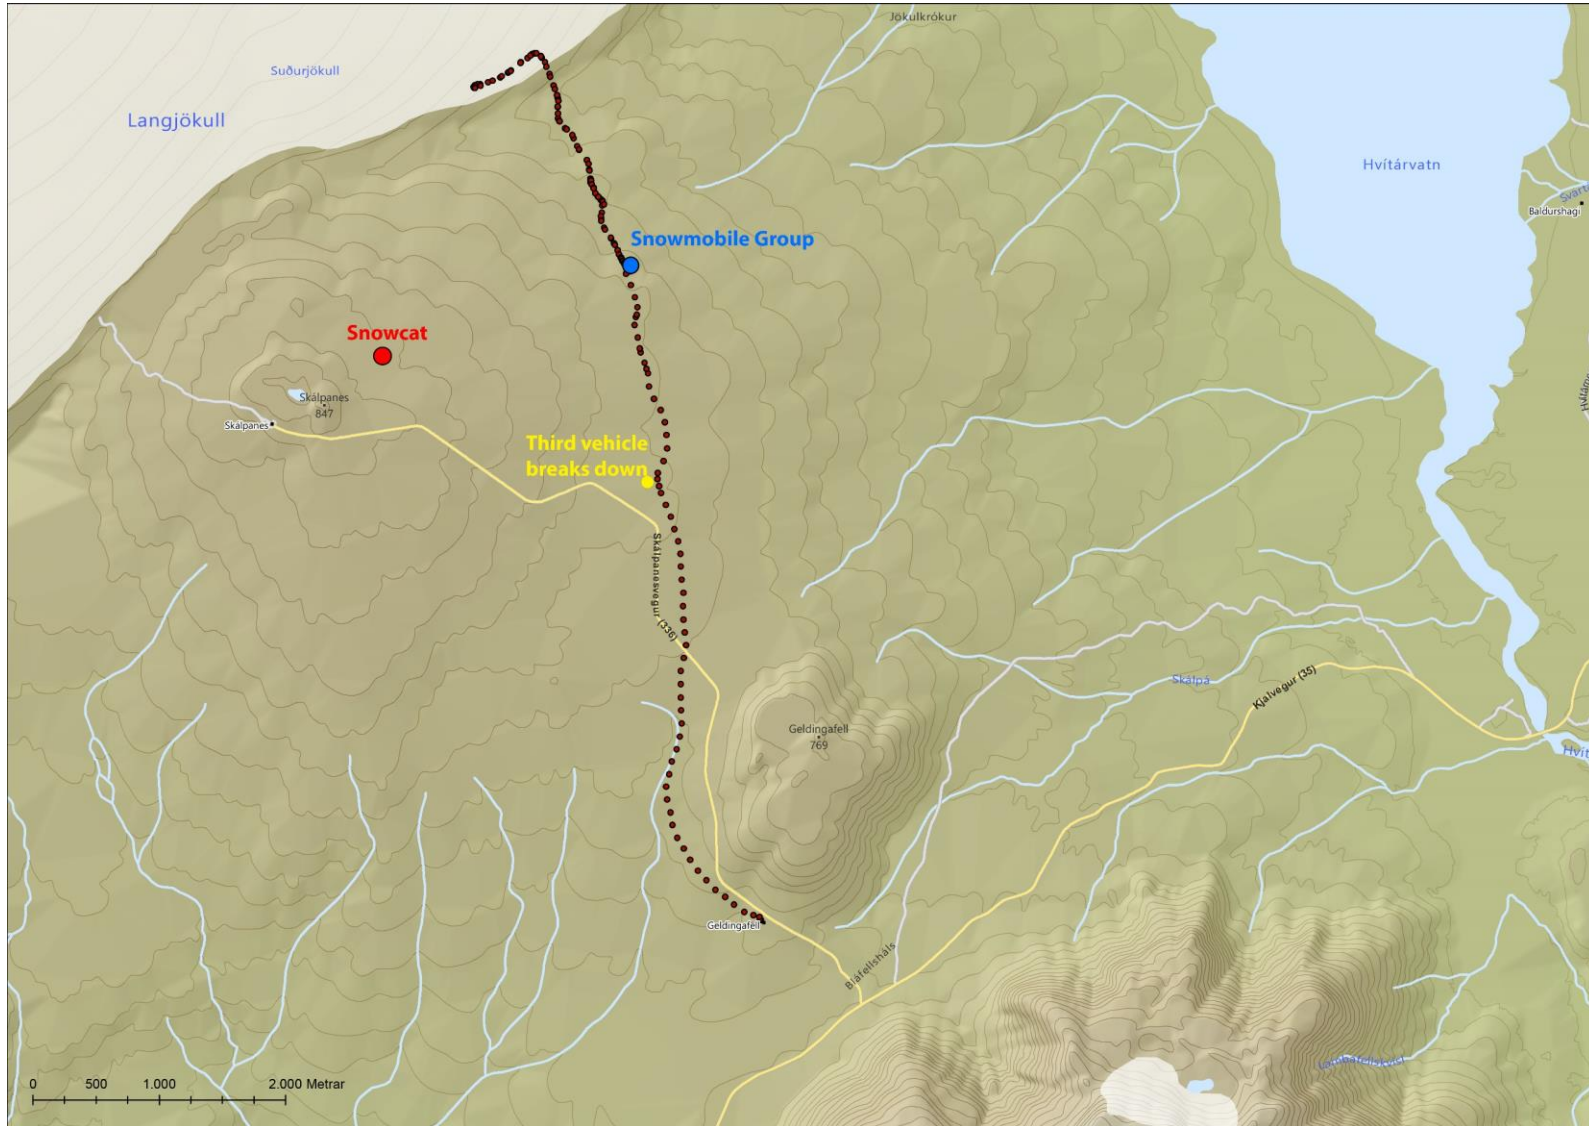
# INCIDENT MAP OVERVIEW

- The group did not depart from the camp on time.
- The terrain was difficult to pass due to loose, airy and uncondensed snow, causing further delays.
- Route to ice cave was not optimal.
- A visit to the ice cave went ahead despite delays, extending the trip beyond the allocated timeframe.
- The snowcat (Plan A) breaks down, the cause is not yet known as the snowcat has not been retrieved at this point.
- One of the super jeeps stops due to the airfilter clogging from the snow.

- Supply shovels on the guide snowmobiles. Strap them down for easy access. They're always fixed on the snowmobiles.
- Purchase Lifesystems (or equivalent) shelter tents. Have them at hand in our basecamp on a snowmobile

- Create a fixed track for ice cave. Compress it with a bulldozer and a trailer. Fit this new route with road markers. Then make it a mandatory route for snowmobile guides.
- If there is any chance of bad weather that day, even in the evening, then the ice cave is cancelled, and clients get a partial refund. A safer snowmobile route is chosen making sure not to venture far from our basecamp.
- Time frame for acceptable weather is increased.
- Lead guide to send in route plans to operations and chief operating officer when trips are operated under yellow warning weather conditions.
- Health and Safety plan to be taken under scrutiny. Mountaineers will hire an independent firm, with expertise in search and rescue operations, to review and amend the Health and Safety Plan.
